# HOW TO FIND A NEEDLE IN A HAYSTACK – FINDING AND FIXING LEAKS AT THE THOMAS E. TAYLOR REGIONAL WATER TREATMENT PLANT

By: Jerry W. Snead, II, PE; Adam McKnight, PE; Tim Brazile

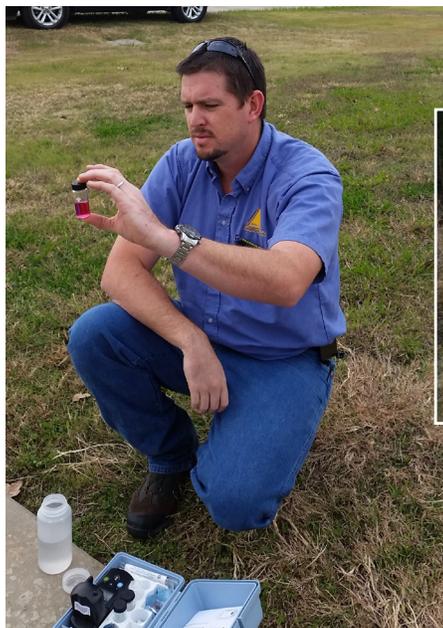
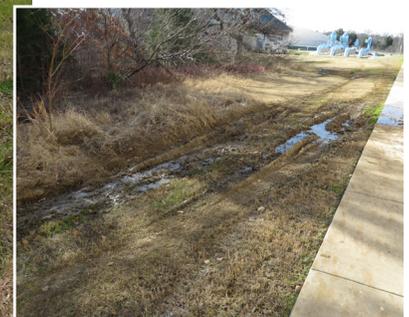
*Taylor RWTP operations staff began noticing leaks and other issues at the plant, including increased flow in French drains located beneath the basins and clearwell. Superintendent, Tim Brazile, confirmed residual chlorine in the plants French drain sump.*

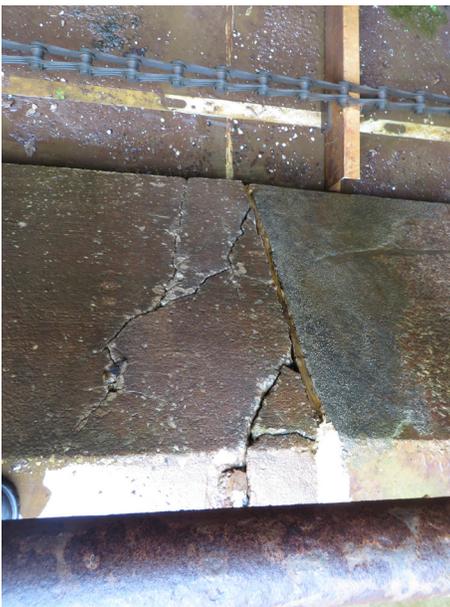
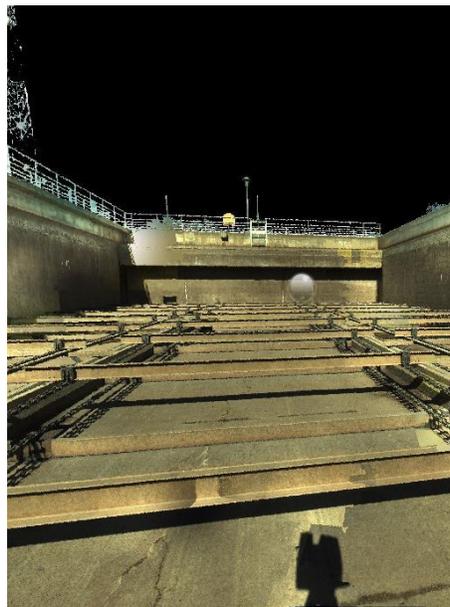
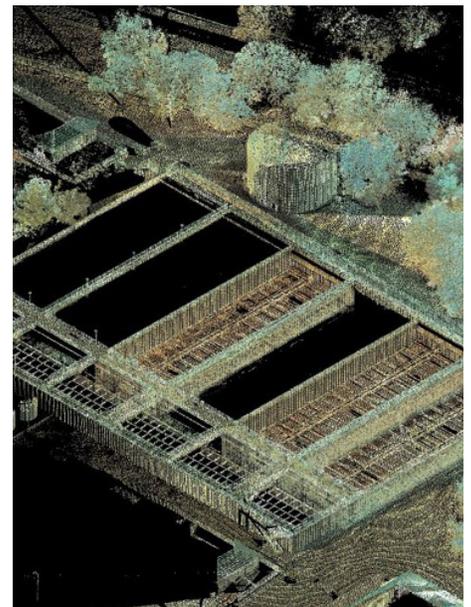
The leak investigation started by evaluating cracks in the RWTP's basin using a variety of techniques, including field observations and LiDAR scans.

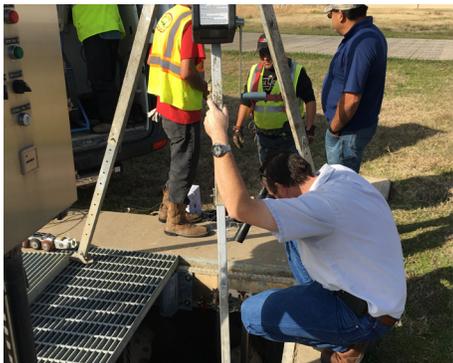
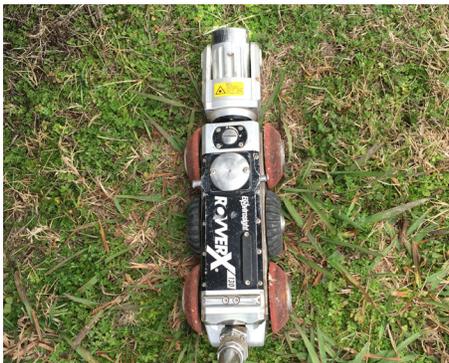
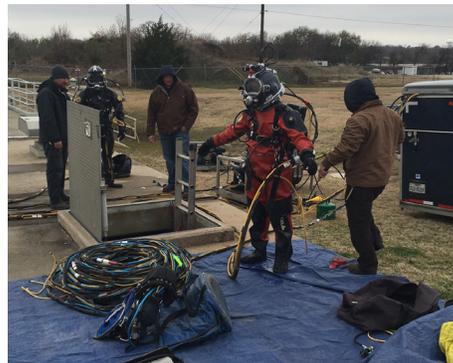
French drains around the clearwell were inspected using a tethered CCTV crawler. Divers used dye and video to inspect the clearwell and its 84-in. connector pipeline.

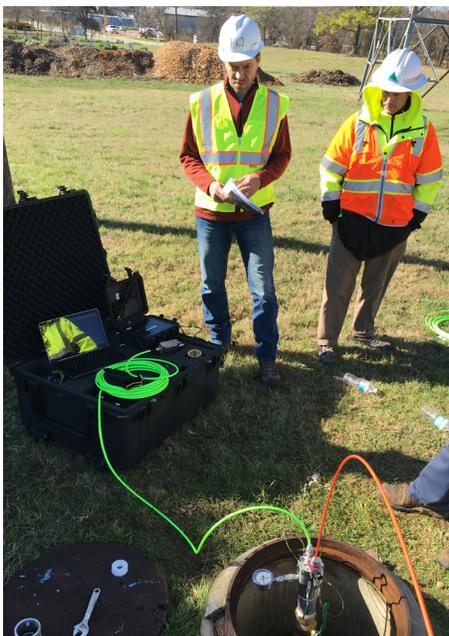
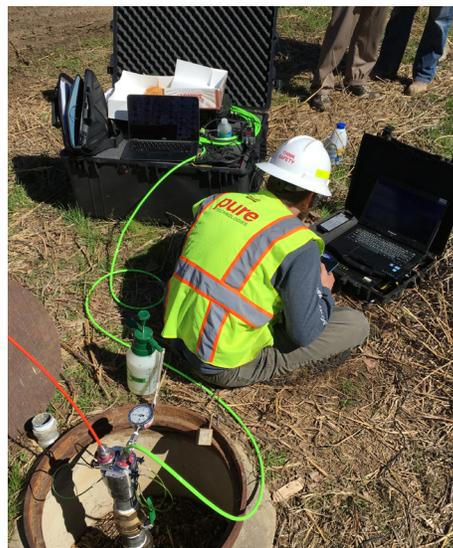
Operations staff exposed raw and treated water pipelines at key locations so the subconsultant could attach acoustic monitoring sensors.
